COMMUNICATION WITH SENSORS LOST ON LOAD ALERT SYSTEM REV 2

NO.118

TECH TIP 118 | RELEASED 09.01.2022 | VERSION 1.0 ©TEREX UTILITIES. ALL RIGHTS RESERVED

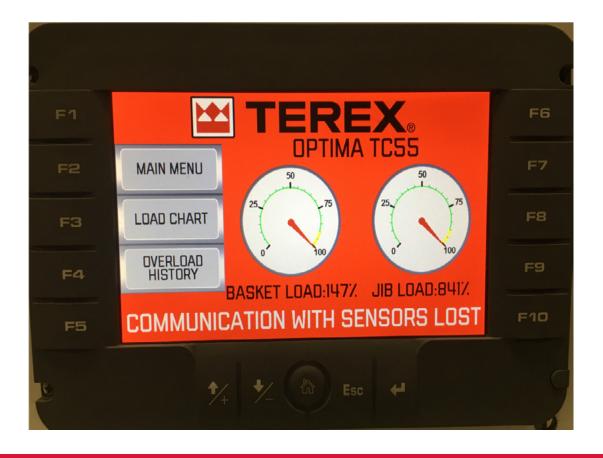
To determine this, go to the Can Network screen by pushing the Main Menu button.

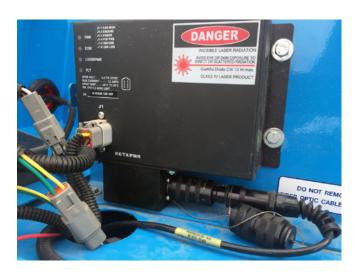
If restarting the PTO didn't clear the error, verify that the connections are tight at the upper and lower fiber optic receivers. One is located at the boom tip and the other is located on top of the lower controls behind the LAS monitor.

Carefully remove the fiber optic connectors and clean both the module end and the cable ends at both receivers. Use the cleaning tool recommended for this cable. Part number is 625558.

- Do not touch the ends of the fiber optic connector or let anything touch the fiber ends
- Only clean the ends of the fibers with the proper cleaning tool
- The fiber optic connectors should be slightly tighter than hand tight
